**British Hang Gliding and Paragliding Association**

# **REPORT**

**Investigation of a Paramotoring incident  
which occurred at Selsey, West Sussex,  
on 22<sup>nd</sup> March 2016  
in which the pilot suffered fatal injury.**

BHPA investigation serial number: IR GBR-2016-3462

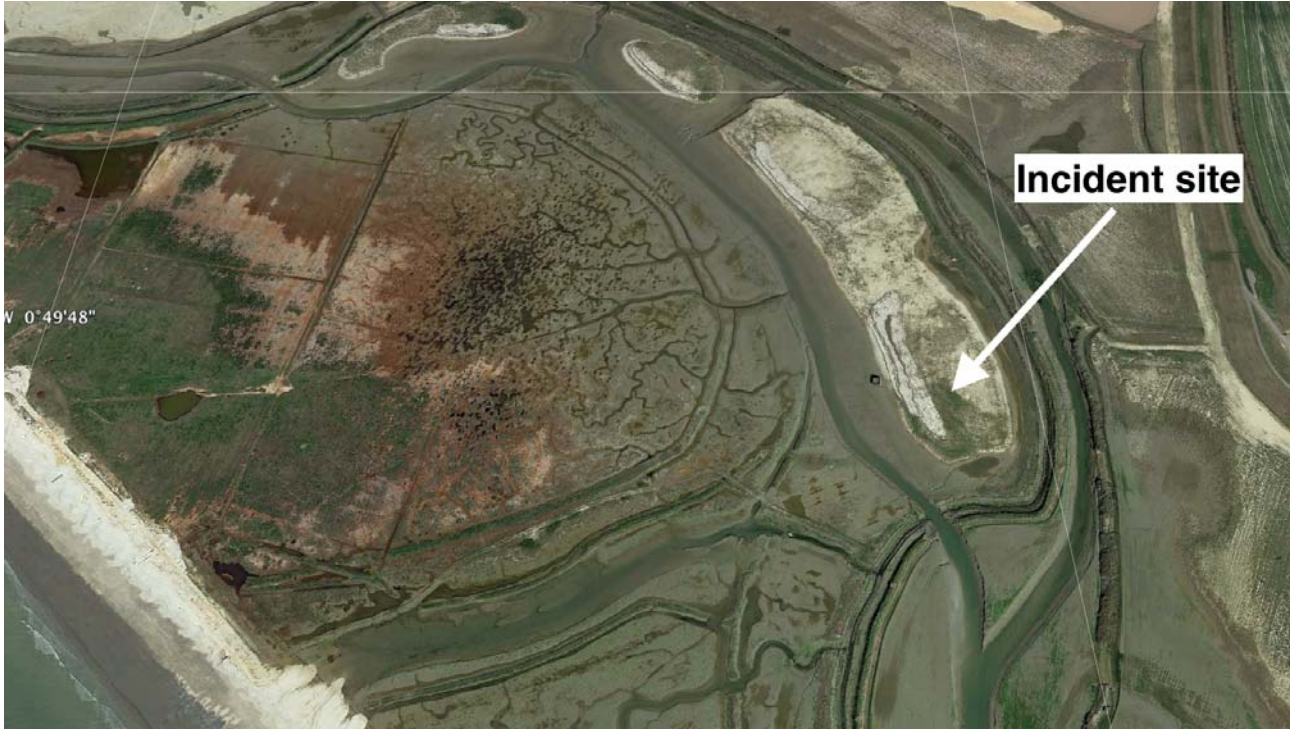
See Photo 1 below.

The incident occurred in the Medmerry nature reserve, just north west of Selsey in West Sussex. The immediate area comprises mainly of marsh with interconnecting streams and inlets that flood with the tide. The exact impact location occurred on an area of raised ground that is not affected by the tide.

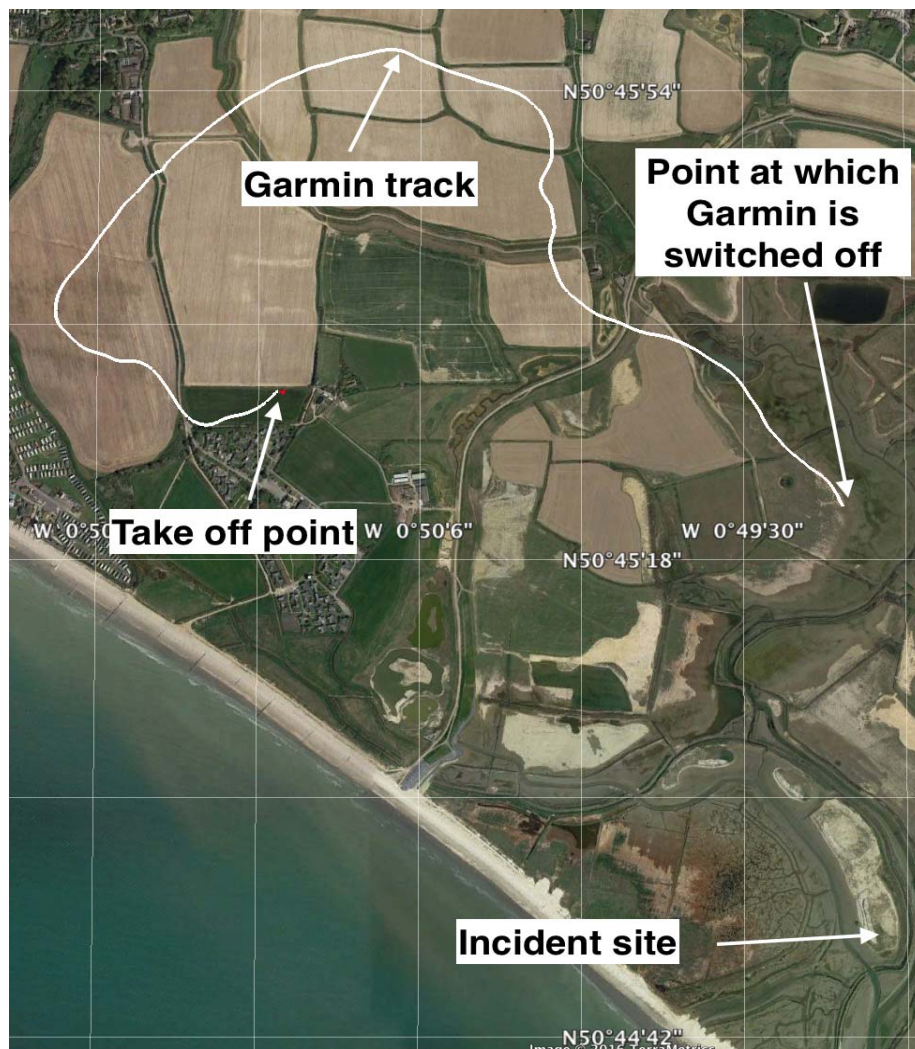
GPS unit was switched on at 16.30 and was subsequently switched off at 17.02. It shows that Pilot A took off at 16.58, three minutes after the micro recorder had been switched off. The Garmin recorded a maximum speed of 57 km/h before slowing slightly to 50km/h just prior to the unit being switched off. There is no indication from the GPS that Pilot A experienced any difficulties for the period of the flight that it was recording data. The picture below shows the GPS track taken by Pilot A and the point at which the unit was switched off. This was approximately 1.2km short of the actual incident site.

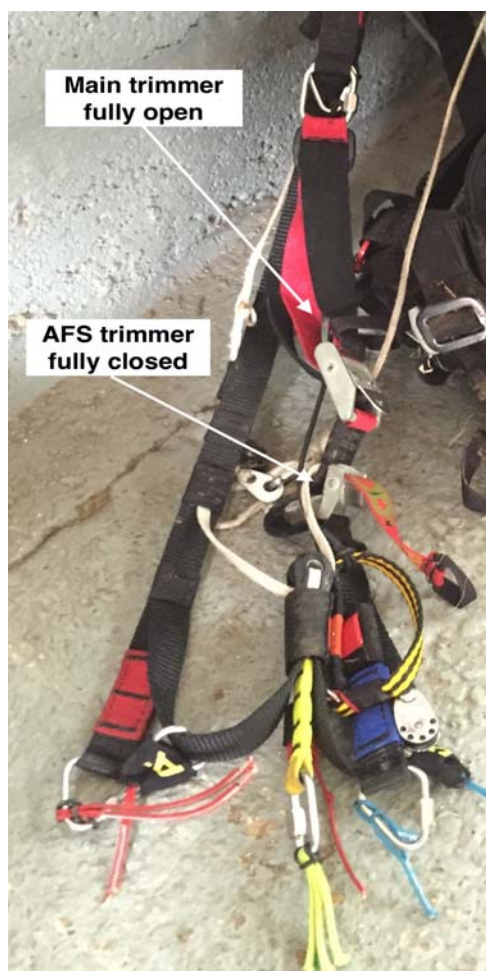
Left side riser set.

Upon inspection it was apparent that the trimmers were not set in accordance with the manual. Both AFS trimmers were fully closed, while both main trimmers were fully open. The photos below show the trimmer settings on the incident glider during inspection.

The manufacturer's user manual for this glider draws the user's attention to the instability of the glider when the AFS trimmers and the main trimmers are set incorrectly. The manual specifically identifies the trimmer configuration in which the incident glider was set as being hazardous, possibly leading to violent / dynamic collapses.

With the AFS trimmers activated as they had been found to be during the incident flight, the use of the main trimmers and/or the speed bar (foot operated accelerator system) would make the glider extremely unstable. The combination of a high flying speed and high wing loading would almost certainly make any collapse of the glider a dynamic departure from normal flight, leading to a high speed rotation and a correspondingly high rate of altitude loss.

It is the view of the Investigation that the incident is most likely to have occurred when the pilot increased his speed, possibly by application of the main trimmers and speed bar. The absence of any further instrument data means it is impossible to say exactly what happened after the initial loss of control but it is evident from witness statements that the glider entered a fast spiral descent. Although the pilot deployed his emergency parachute there was insufficient height for the parachute to slow his descent to a survivable rate. The Investigation considers the configuration of the trimmers to have been a major factor in this incident.

The Investigation recommends that the BHPA, via its members' magazine Skywings, remind pilots of the necessity of becoming fully familiar with any unusual features of their aircraft, and also of the dangers of flying gliders with high wing loading
