## BHPA Incident Report: GBR-2018-5514

### INCIDENT

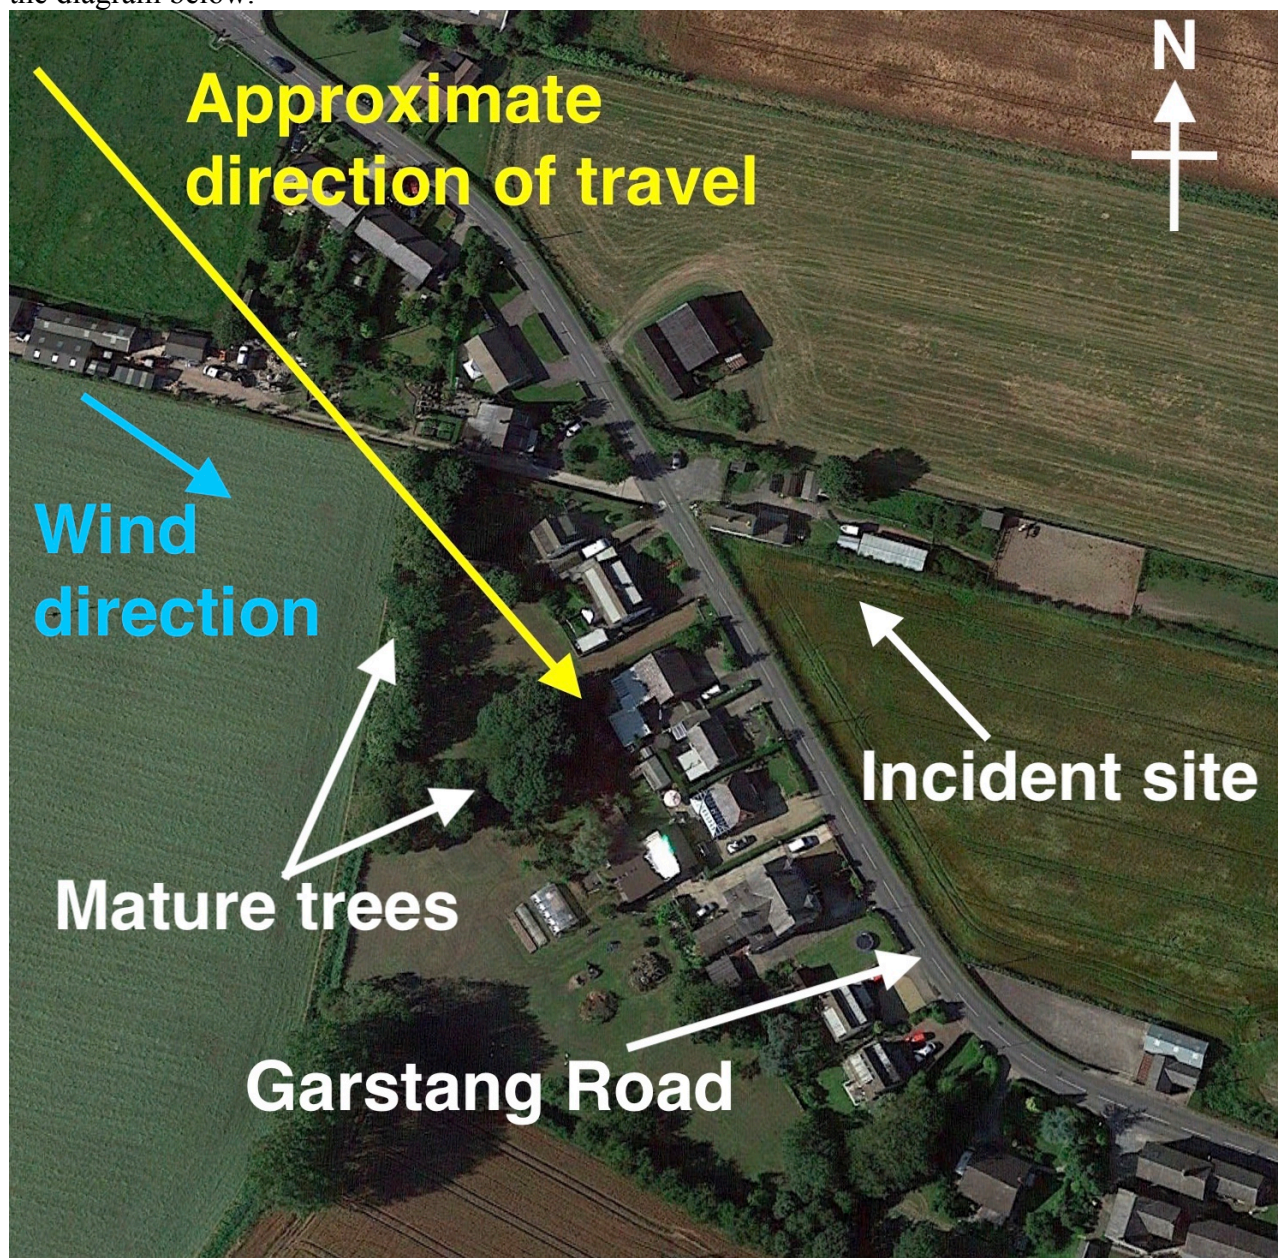
and out of local villages. At the time of the incident Pilot A was seen to be flying at a relatively low altitude, parallel to the Garstang road. He had just passed a line of mature trees when he was seen to descend rapidly in a spiral. Pilot A's flight path and the prevailing wind direction are shown on the diagram below.

It is possible that Pilot A encountered turbulent air as a result of flying low and on the lee side of the mature trees and buildings, resulting in a loss of control and crash. The turbulence may have been exacerbated by the fact that the trees were downwind of other buildings and trees along the line of the road Pilot A was following.

The investigation finds that the altitude of the pilot while flying over and into the lee side of mature trees was a significant factor in this incident.
