## **BHPA Incident Report: GBR-2018-9122**

Pilot A was making a local flight on his powered paraglider (paramotor) from a field near the village of Bishop Norton with other paramotor pilots. During the landing phase of his flight, he collided with a tree on the periphery of the landing field and fell to the ground. He was attended to by the other pilots but died from his injuries.

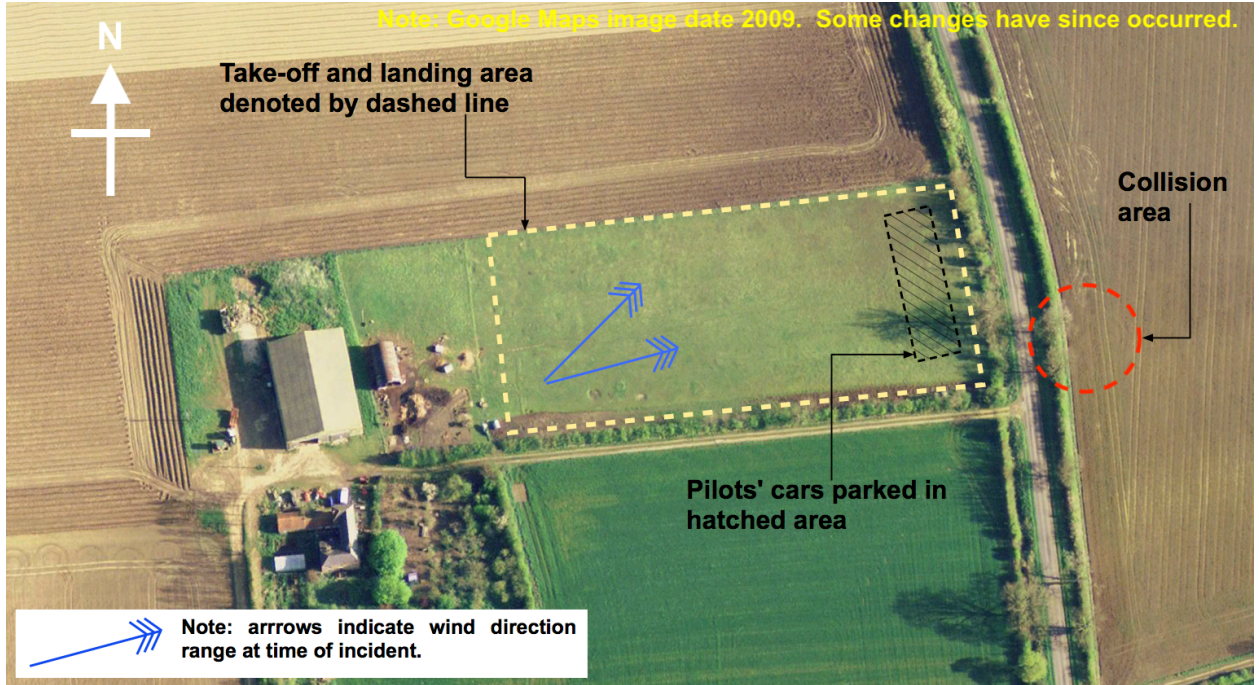
The flying area is generally flat farmland. The field used by the pilots for launching and landing has established trees on either side of the road at the eastern boundary of the field (refer to *fig. 1*, below). On the southern boundary is a hedge and occasional medium height trees along its length. Situated at the western end are a farmhouse and farm sheds, and a line of established tall trees approximately 200 metres from the area of the field used by the pilots on the incident day. The northern boundary has no obvious obstructions to the airflow. Running along the field's eastern and southern boundaries are telecom cables on poles.

The Investigation considers the site to be suitable for powered paragliding, however, turbulent air would be expected in the lee of the buildings and tall trees, and caution would need to be exercised when flying in a moderate windspeed, especially with a westerly component.

Fig. 1 (above). Indicative aerial picture of the activity field, showing the trees and approximate impact area in the dashed red circle. (not to scale).

Pilot C stated that he considered Pilot A to be “quite low at about 15 feet”, and that his heading appeared to be between the two tall trees on the other side of the road from the landing field’s eastern boundary. Pilot A’s height above the ground and high ground speed toward the field boundary and the trees would have made a collision with an obstacle on his flight path highly probable.
