## **BHPA Incident Report: GBR-2019-11434**

### **INCIDENT**

| <b>Aircraft Type:</b> | Advance Sigma 10 paraglider, size 29. Serial number 7635P75945. Harness, Gin Genie Lite 2, size large. Serial no. 0716-VGL20230L. Harness fitted with High Adventure Beamer 3 parachute. Size 130kg. |
| <b>Date and Time:</b> | Tues 23rd July 2019. 13:40-13:50 (BST). |

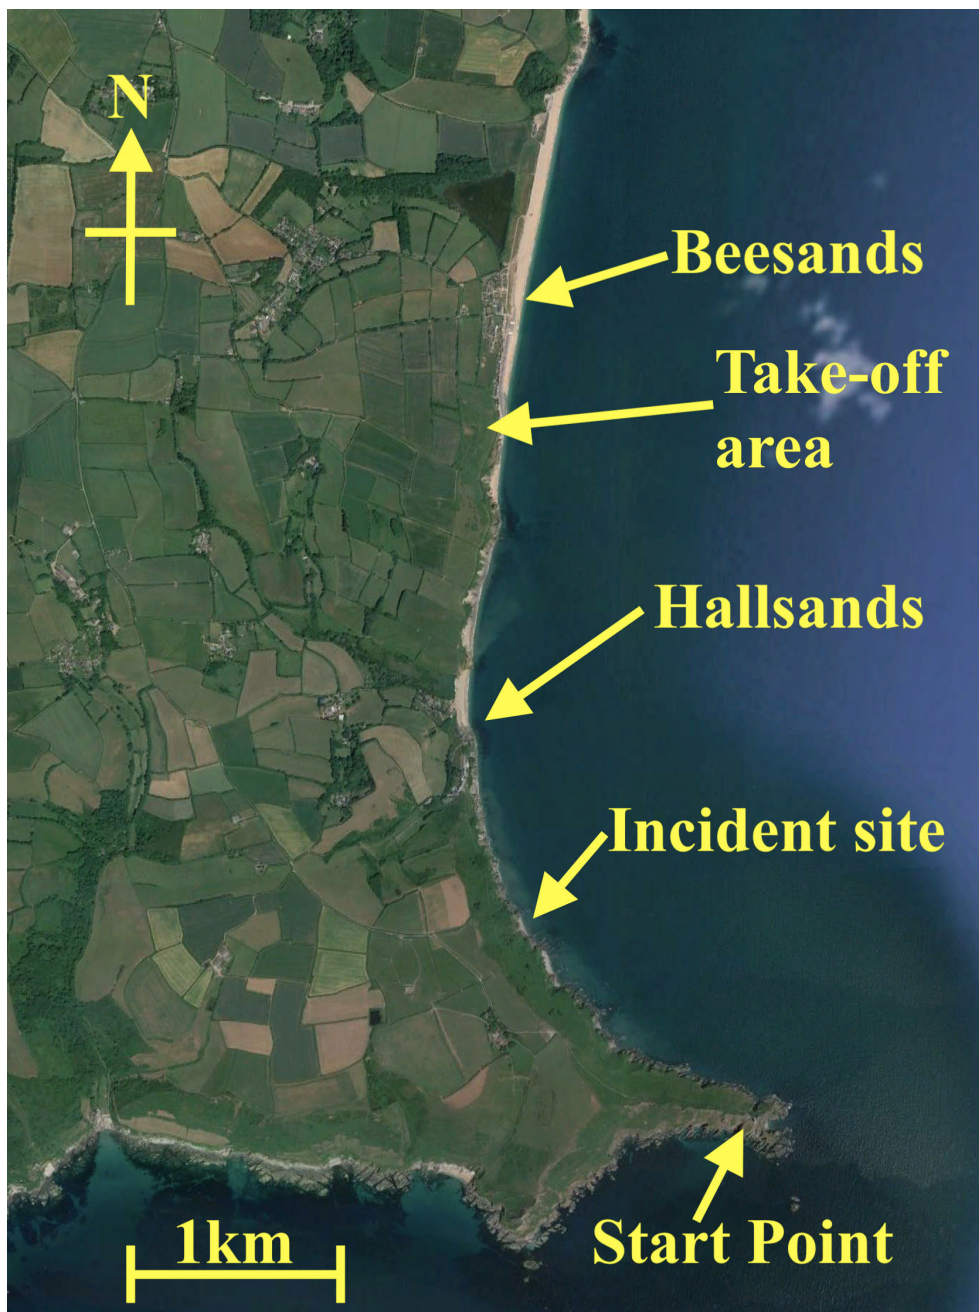
Google Earth image 1 below, shows the main section of coastline from the take-off down towards Start Point:

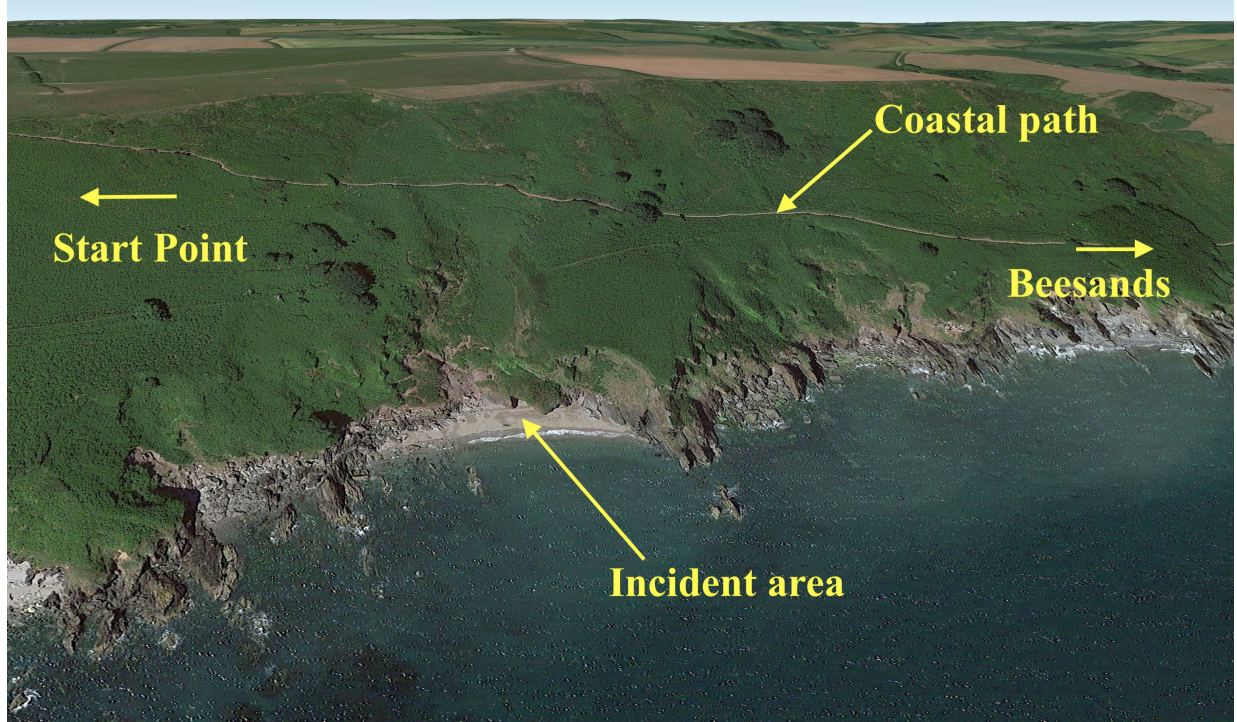
Google Earth image 2 below, shows the incident site and coastal footpath. Image 2 shows the sea level at approximately 4 to 4.5 hours after high tide.

At the time of the incident the tide was on its way out. The incident occurred approximately half way between high and low tides. In this area of the coast the tidal range is relatively small, being approximately 2.5m on the day. Any areas of beach associated with the few small inlets in the immediate area would have been extremely small. Making a landing on such a small, enclosed area would be a matter of chance, if possible at all. Given that Pilot A was losing altitude in the light winds, his ability to glide to a suitable landing area would have been severely limited.

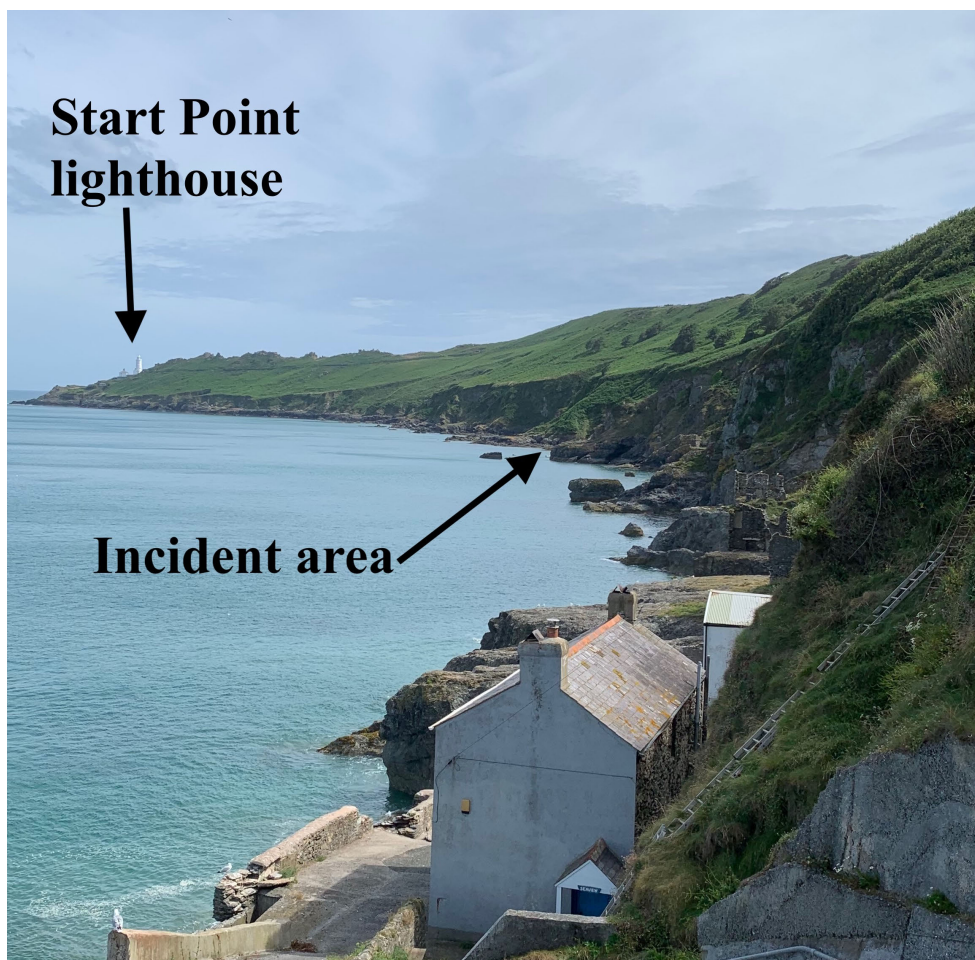
It is clear from the club site guide that the lack of safe landing areas when flying in the area of Start Point is well known and documented.

Photo 1 below shows the view along the cliffs looking in a southerly direction from the Lost Village, just south of Hallsands:

The investigation recommends that the BHPA, through its member's magazine Skywings, reminds pilots of the importance of always having a landing area available, and especially when flying at coastal sites.
