## **BHPA Incident Report: GBR-2020-14020**

### **INCIDENT**

| <b>Aircraft Type:</b> | Paraglider: Ozone Zeno ML (serial number ZENML-R-47B-013); Swing Connect Race pod harness fitted with Gin Yeti 40 emergency parachute; Flymaster GPS SD electronic flight instrument. |

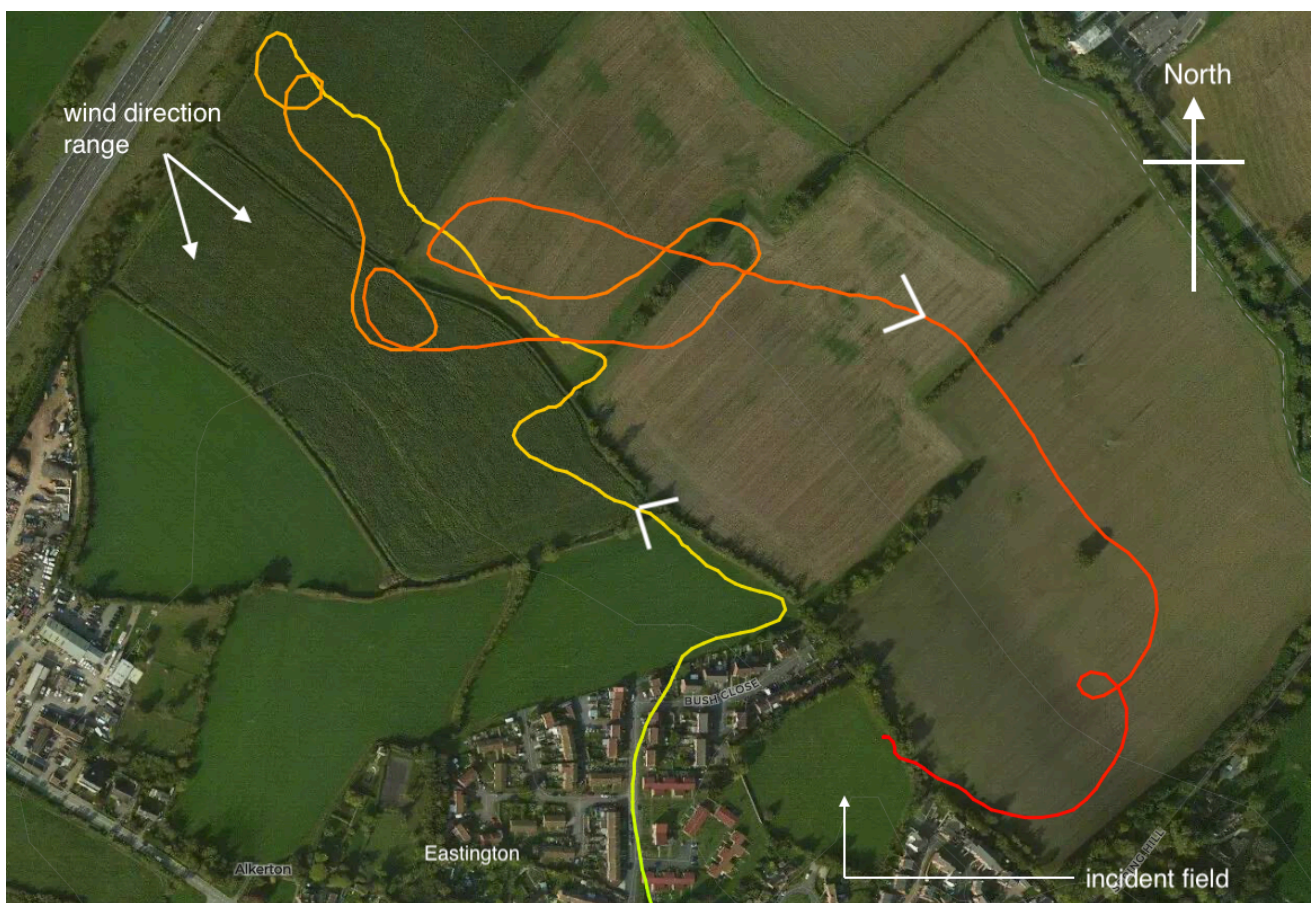
The Investigation considered the portion of the flight in the ten minutes leading up to the contact with the power cables. The flight data was provided by an analysis of the GPS tracklog from Pilot A's electronic flight instrument. The GPS track for this portion of the flight is displayed in Fig. 1 (below).

At approximately 12:00 UTC Pilot A contacted Witness D from the air by mobile 'phone to say that he would be landing near his home. He asked for a lift to retrieve his car from Selsley hill. The GPS track indicates that at the time this call was made he was about to fly over Eastington, crossing from the south of the village. After crossing Eastington, Pilot A turned northwest, heading into wind. His altitude at this point was approximately 1000ft above mean sea level and he remained generally on a descending glidepath for the remainder of the flight, losing height with a series of turns over fields to the north of Eastington.

Approximately two minutes before Pilot A crossed the boundary of his intended landing field (the incident field), he turned to fly downwind, his flightpath crossing some large fields. These fields contained high voltage power cables on pylons or wooden poles, however there were large open areas affording potential alternate landing options. Police drone footage from the incident day shows that the two fields that Pilot A flew over before reaching the incident field contained low crops.

Fig. 1 (above). Overlay of GPS track. Direction arrows added to indicate flight direction.

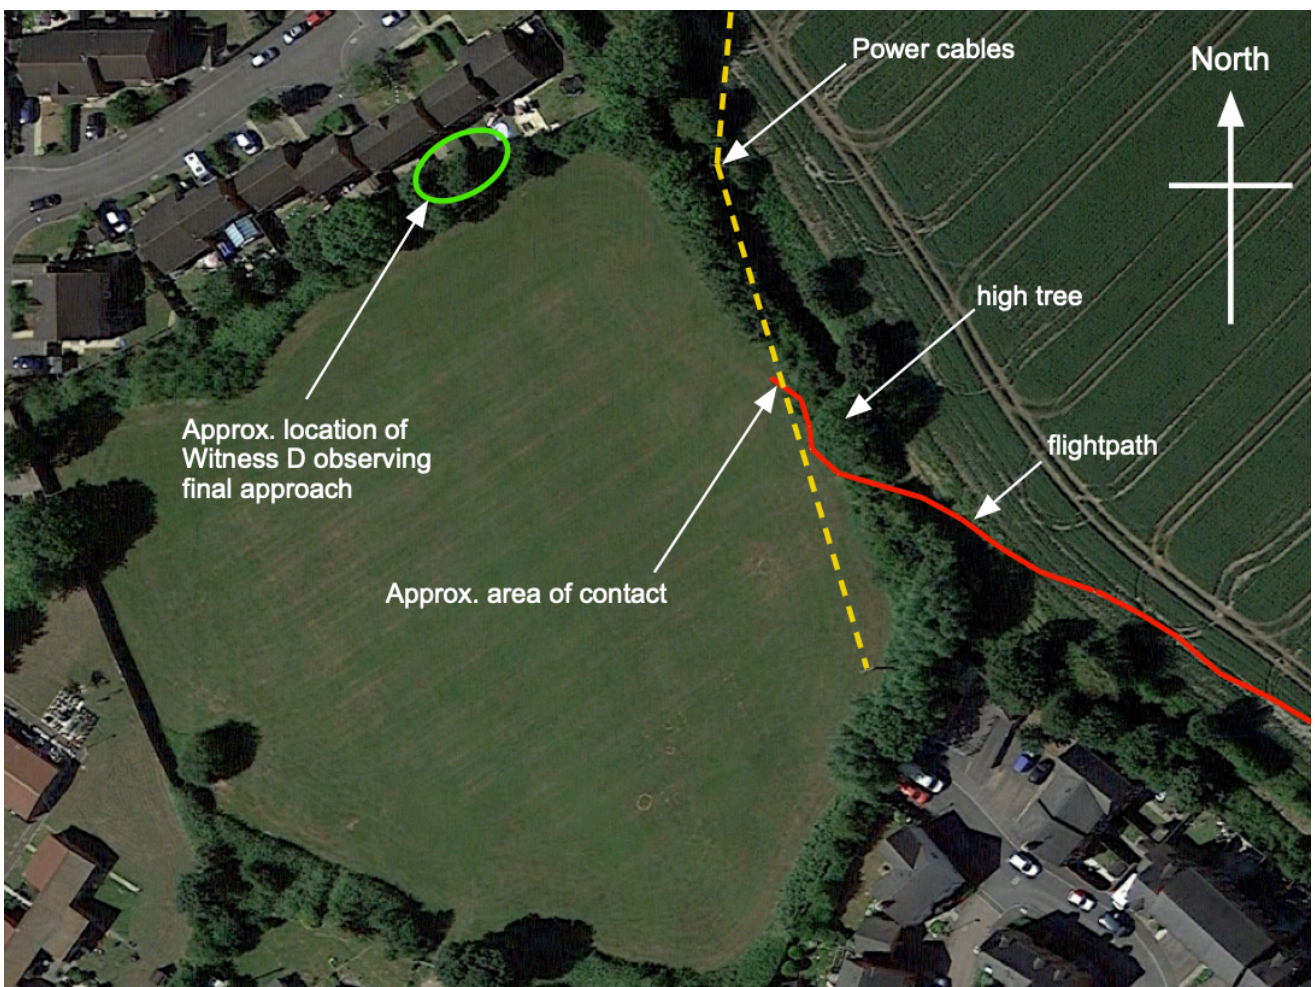
From their position near the north boundary of the field (identified on Fig. 2), Witness D observed Pilot A flying directly towards them. It is evident that at this stage Pilot A was gliding into wind on

Pilot A’s GPS track illustrates that his course and height above ground required him to make a slight course deviation to his line of approach to pass to the left-hand side of a tree quite substantially higher than the surrounding foliage on the field’s boundary hedge (identified on Figs. 2 and 3). This line of flight brought him into contact with the power cables at approximately 8 to 9 metres above ground level.

*Fig. 2 (above). The incident field, final glide flightpath and power cables location.*

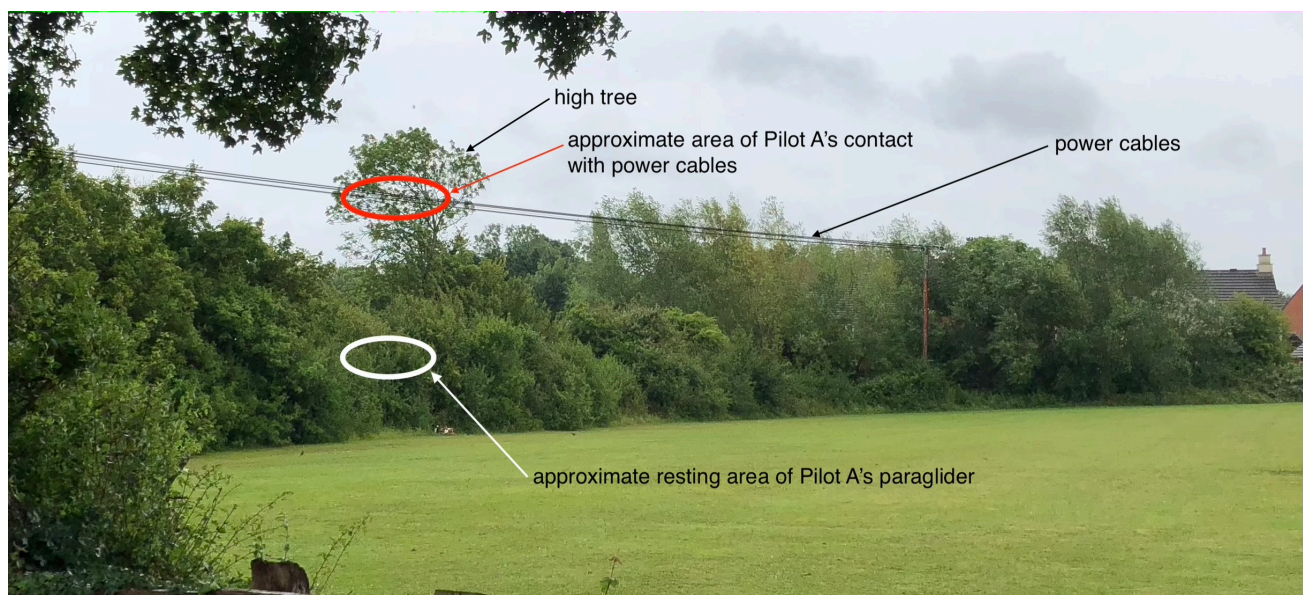
*Fig. 3 (above). View of the field's northeasterly boundary from Witness D's approximate position when observing the incident. The power cables have been digitally enhanced for clarity against the background.*
