## **BHPA Incident Report: GBR-2020-15628**

| <b>Aircraft Type:</b> | Paraglider: Ozone Delta 3 ML (serial number D3ML-S-12B-080); Advance Impress 3 pod harness fitted with Independence EVO 22 emergency parachute (serial number 35323); Flytec Element electronic flight instrument. |
| <b>Location:</b> | Windy Knoll landing field, High Peak. |
| <b>Date and Time:</b> | 14 <sup>th</sup> August 2020, approximately 17:52 UTC. |

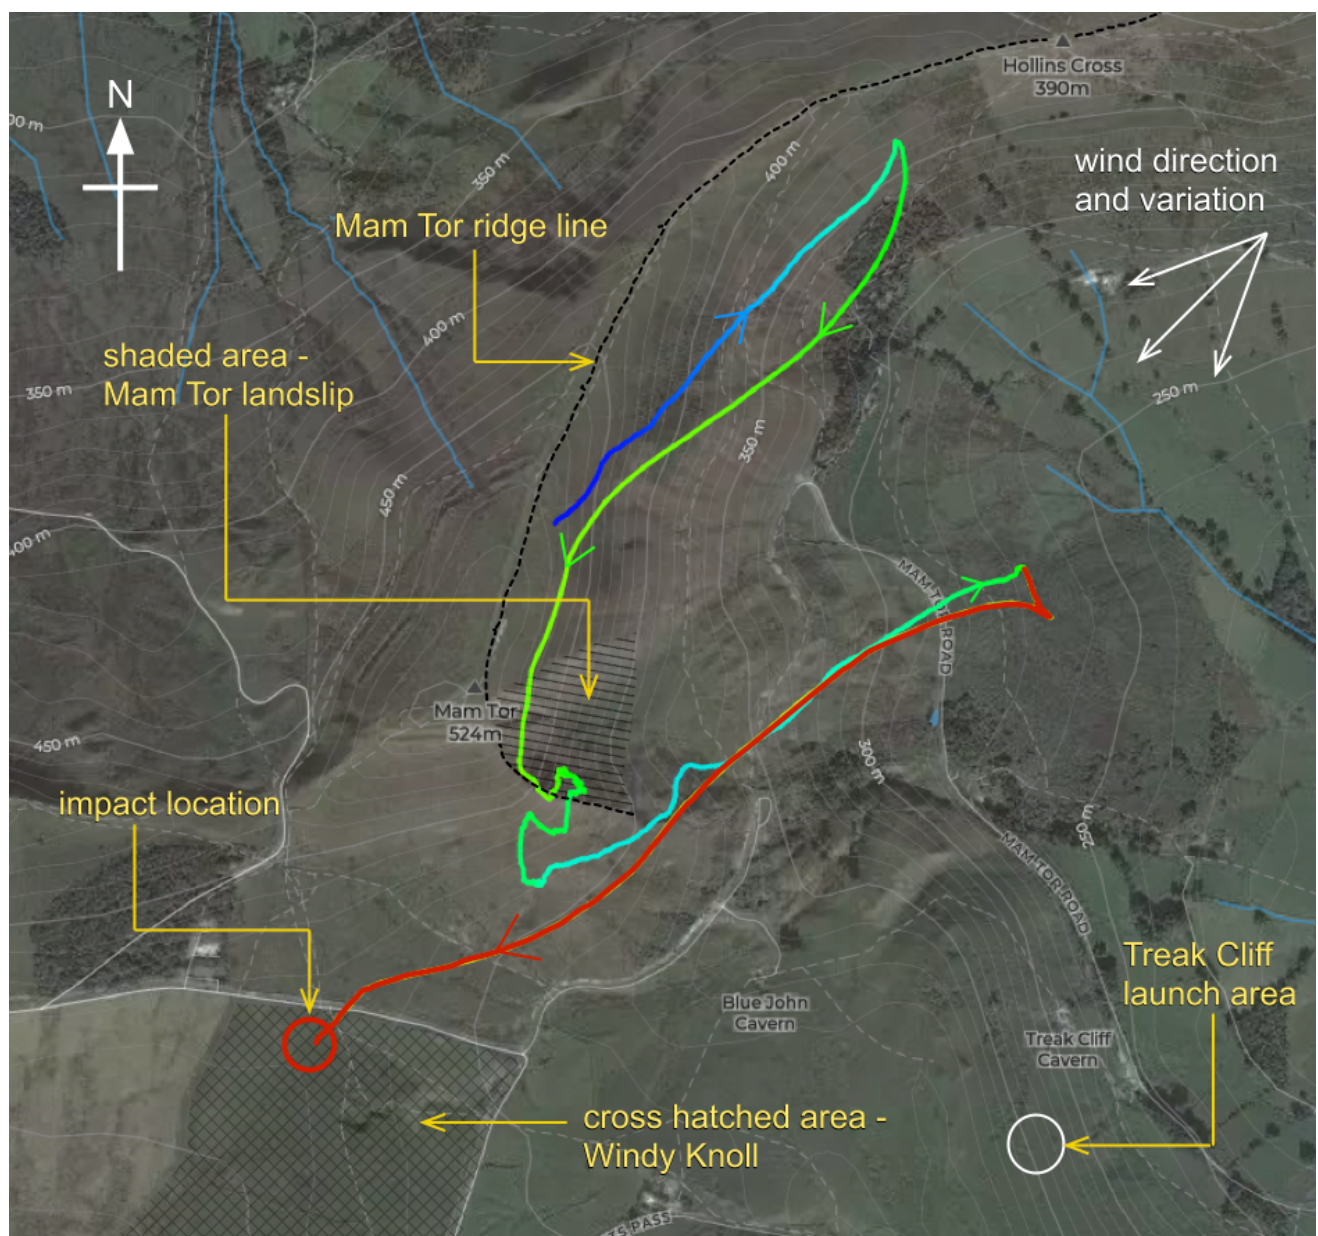
Fig.1 (above). The solid red line indicates Pilot A's downwind glide towards Windy Knoll. The blue / green line indicates the portion of flight immediately prior to this. (Image source: Naviter "SeeYou").

Pilot A flew in a northeasterly direction towards Hollins Cross (identified on Fig. 1 by the blue line). This leg of the flight was into wind, his speed over the ground averaging 11mph. He then turned to fly in a southwesterly direction (the green line on Fig. 1), his groundspeed increasing to around 40mph, this time flying downwind.

At 17:45 UTC, five minutes before the incident, Pilot A turned into wind, approximately 1000ft above the ground at this point. His ground speed on this leg averaged just below 10 mph and he flew away from the hill in an east-northeasterly direction, losing altitude, before turning downwind towards Windy Knoll (the red line on Fig. 1). Pilot A's groundspeed on this downwind glide averaged 42mph and he lost approximately 100ft of altitude, arriving approximately 350ft above Windy Knoll.

The Investigation determined that the precipitating factor that led to the incident was Pilot A's decision to land at Windy Knoll, where his height above ground and selected track downwind put him directly in the lee of Mam Tor and the landslip edge. Given the wind speed and direction at the time, his chosen route in the lee of these features known to create significant disruptions to the airflow exposed him to a high risk of experiencing a departure from normal flight in turbulent air.
