**British Hang Gliding and Paragliding Association**

# **REPORT**

**Investigation of a Paramotoring incident  
which occurred at Selsey, West Sussex,  
on 22<sup>nd</sup> March 2016  
in which the pilot suffered fatal injury.**

BHPA investigation serial number: IR GBR-2016-3462

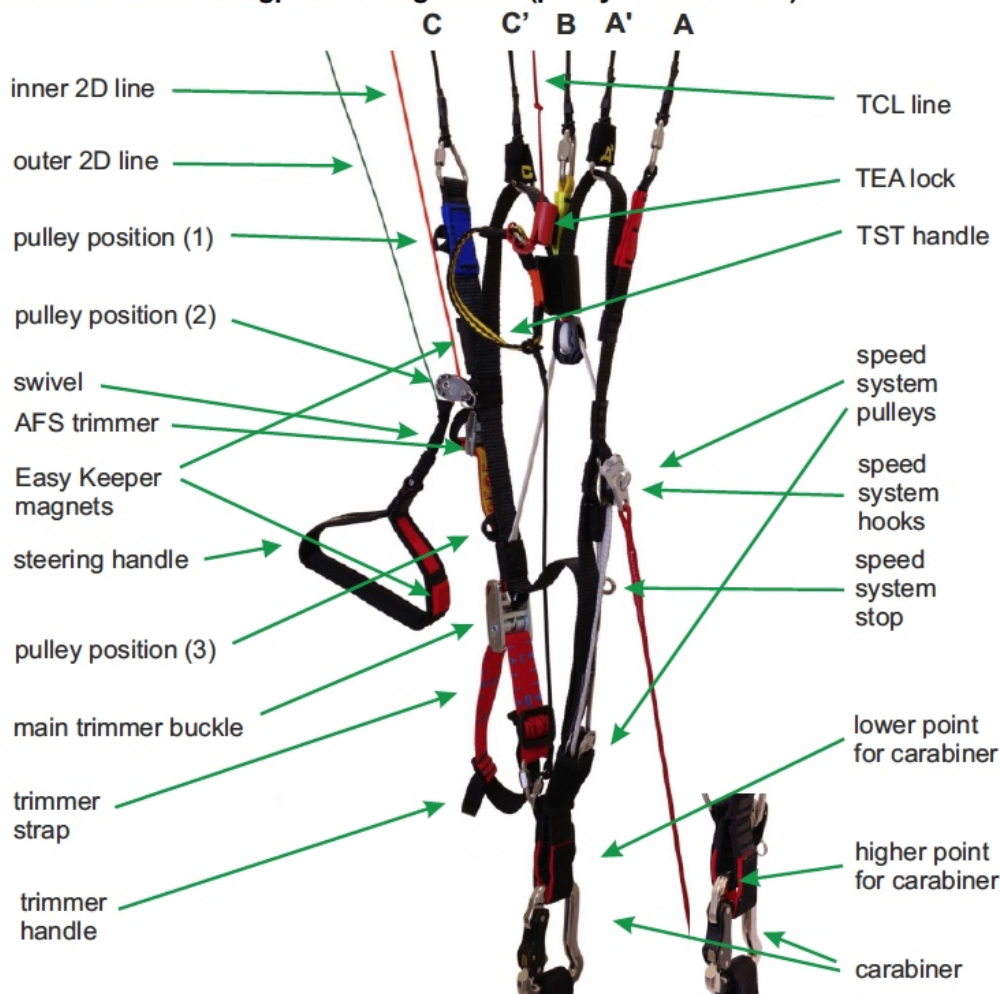
### Risers in lower hangpoint configuration (pulley in the middle)

The Hadron user manual makes it clear that the correct configuration of the trimmers, and in particular the AFS trimmer, is critical and that incorrect setting can result in violent collapses. The very first page of the manual is taken up by a warning highlighting the importance of the configuration setup and draws particular attention to the AFS trimmers. This page is included in the appendix, as is a link to the whole manual. Throughout the manual there are numerous references to the riser set up and the importance of correct configuration. From 26th March 2016, Dudek began supplying the Hadron XX with AFS-2 risers. The AFS-2 system prevents the main trimmers from being activated whilst AFS is engaged.

The manufacturer's user manual for this glider draws the user's attention to the instability of the glider when the AFS trimmers and the main trimmers are set incorrectly. The manual specifically identifies the trimmer configuration in which the incident glider was set as being hazardous, possibly leading to violent / dynamic collapses.

With the AFS trimmers activated as they had been found to be during the incident flight, the use of the main trimmers and/or the speed bar (foot operated accelerator system) would make the glider extremely unstable. The combination of a high flying speed and high wing loading would almost certainly make any collapse of the glider a dynamic departure from normal flight, leading to a high speed rotation and a correspondingly high rate of altitude loss.

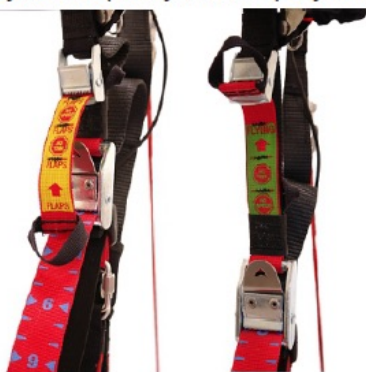
System AFS (Aerodynamical Flaps System)

**AFS (Aerodynamical Flaps System)** - by additional little trimmer you can partially modify the airfoil (like flaps in the aircraft). Before attempting actions like take off/landing in nil wind or thermal flying, the little trimmers should be pulled in, that is activated. At all other flight parts little trimmer should be opened (inactive).
